Multiple Fatality High-Rise Condominium Fire

Clearwater, Florida - June 2002

Technical Report Series - USFA-TR-148

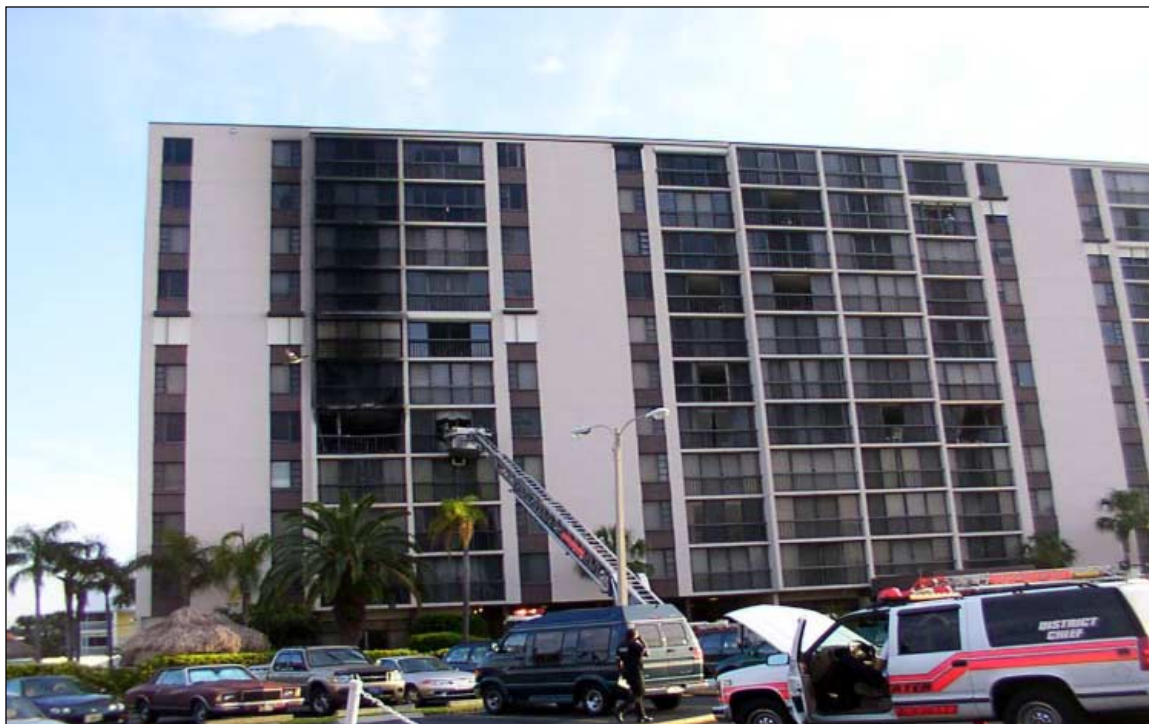
1. View of southwest corner of building; note location of Truck 45 and open sliding glass door of Unit 501 (area of origin) and extension up exterior face of building

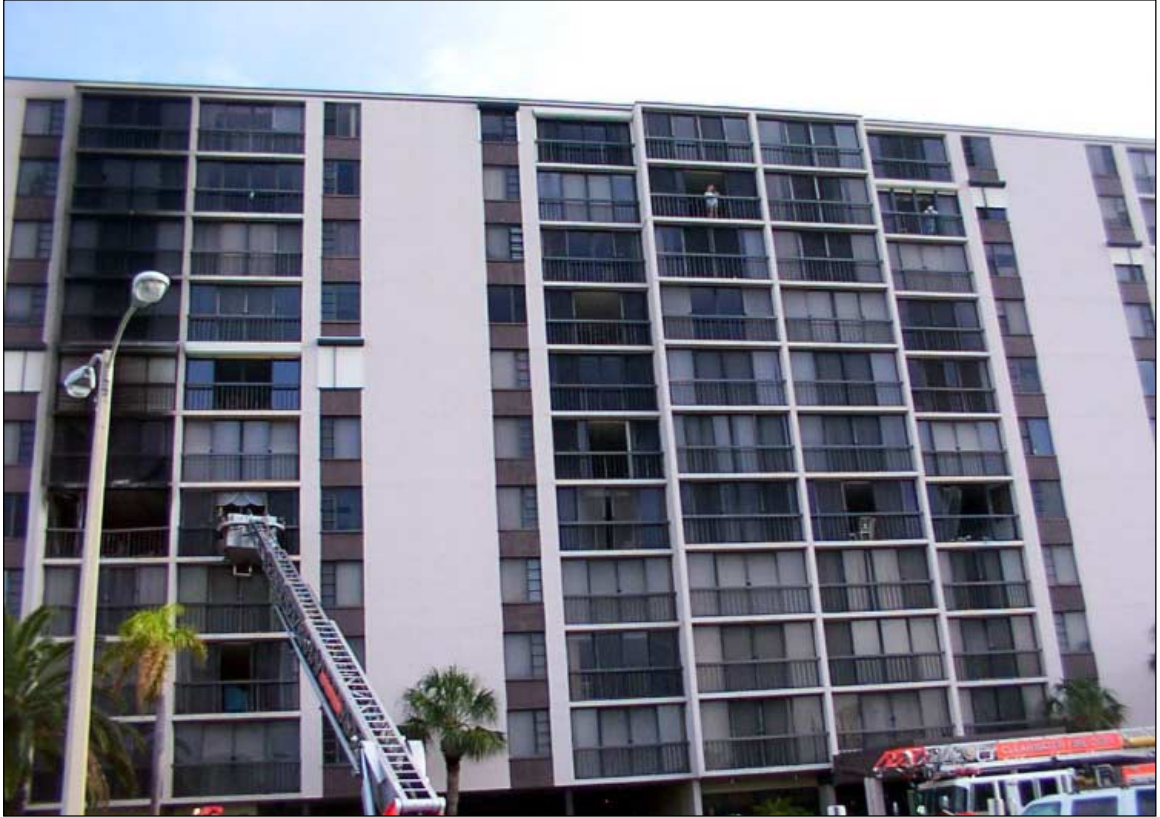
3. Note occupants on 10th floor balconies. This provides indication of the narrow depth of balcony landings.

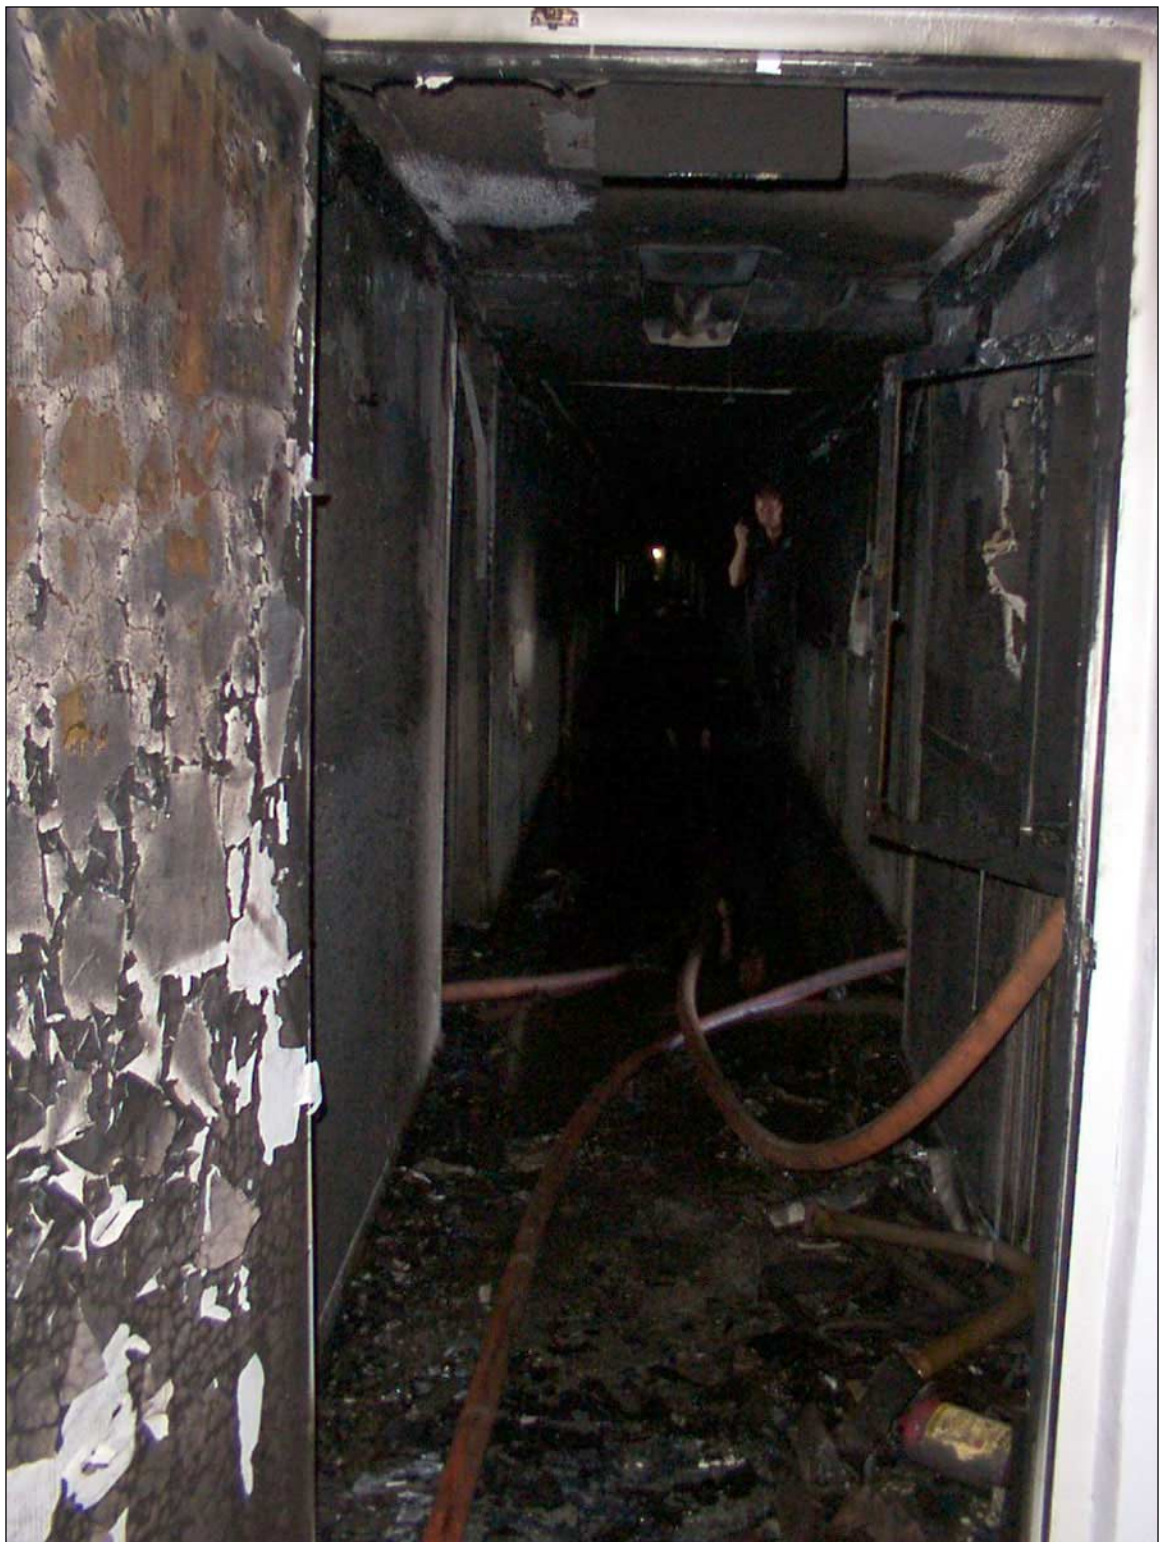
4. View of damage to fifth floor hallway.

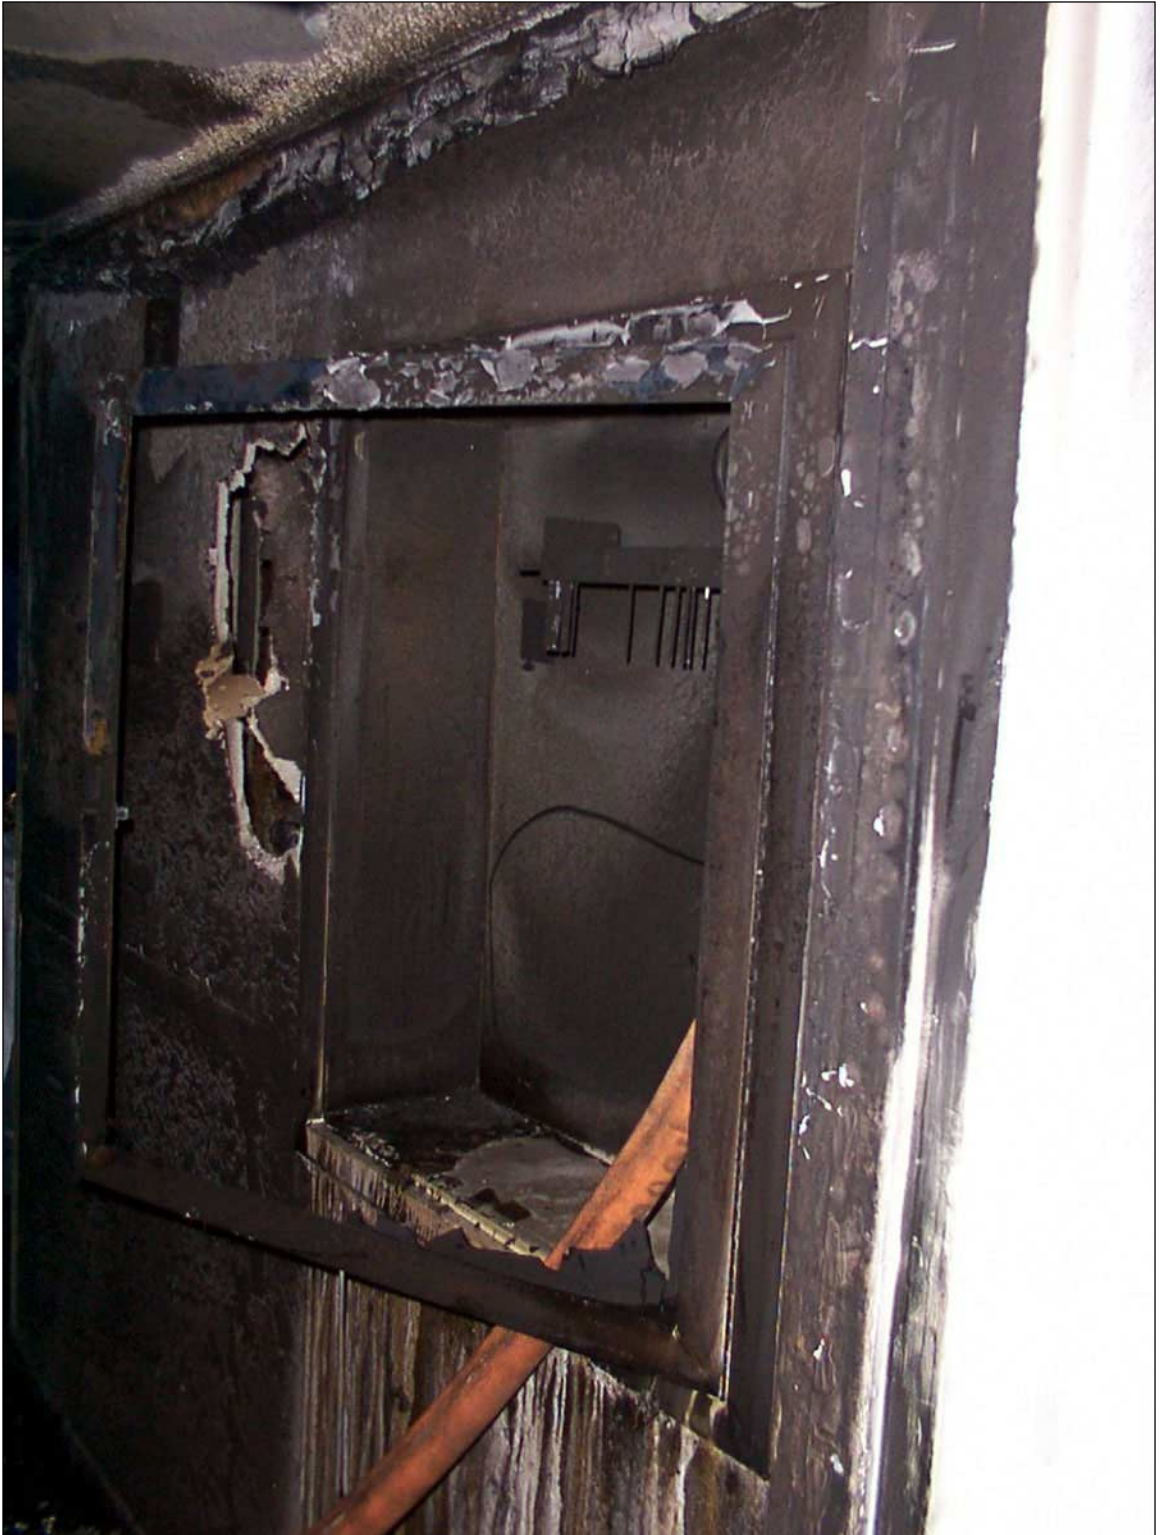
5. View of FD line attached to standpipe connection near west stairwell.

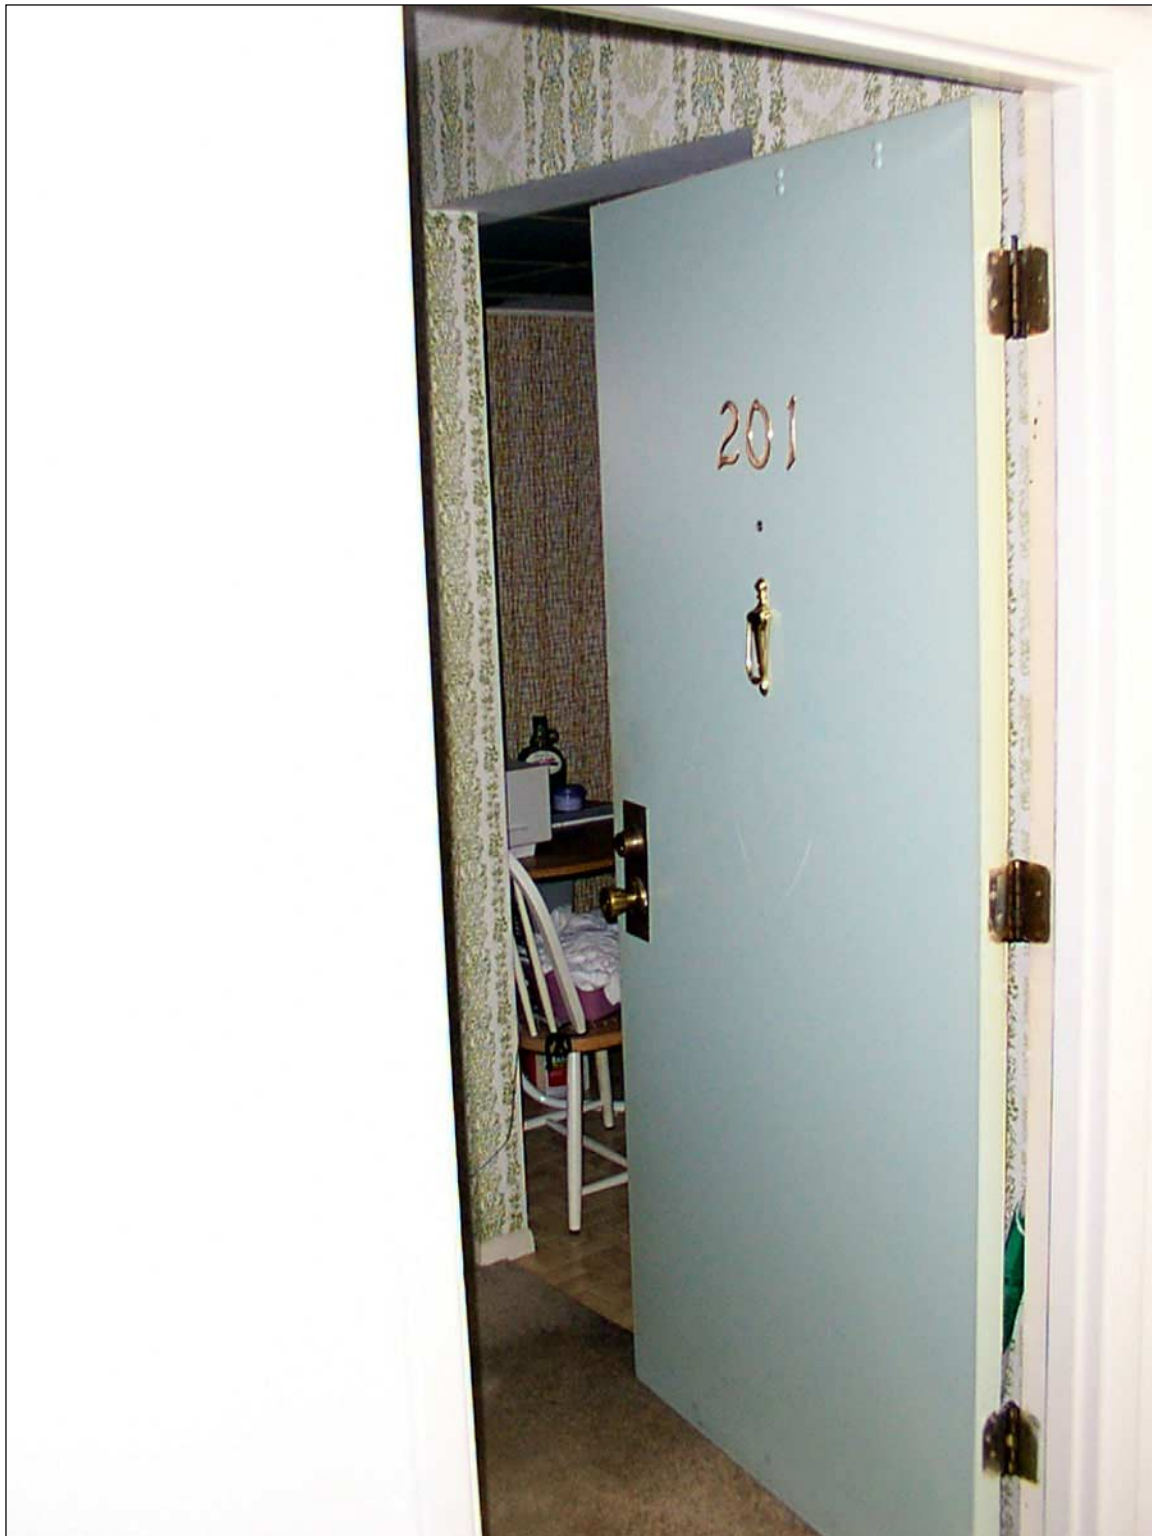
6. Representative occupancy door to condo units. This unit is three floors below unit of origin and is equipped with automatic door closure.

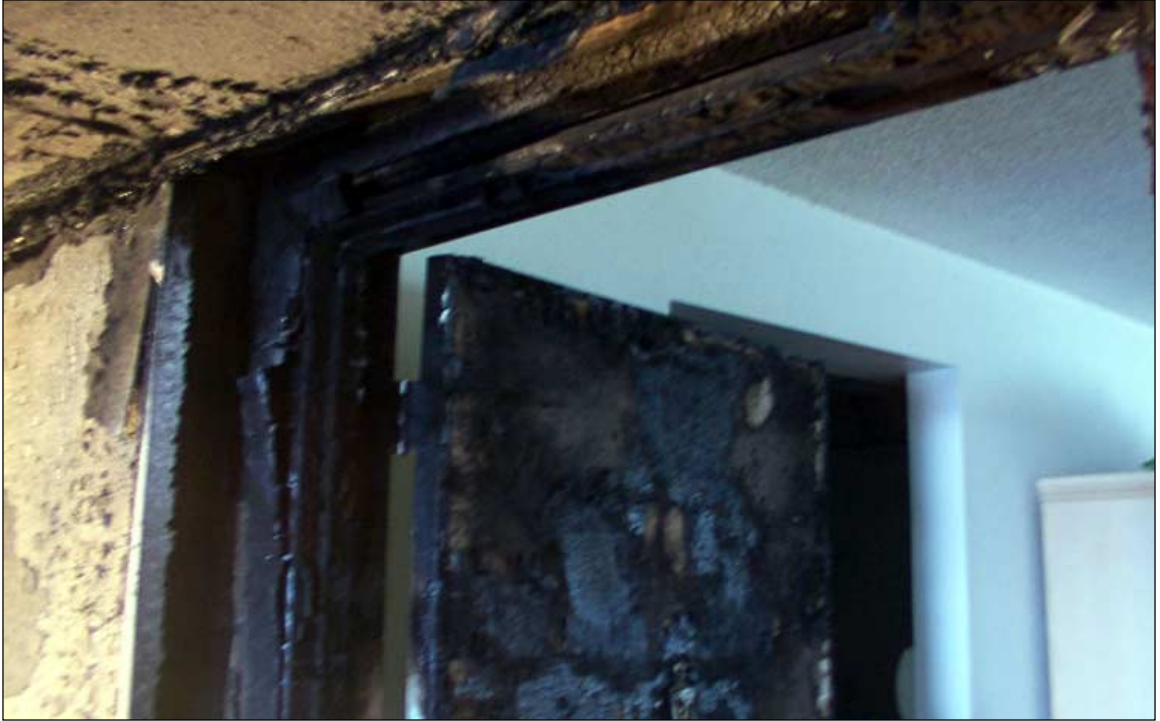
7. Door to Unit demonstrating how well the doors held

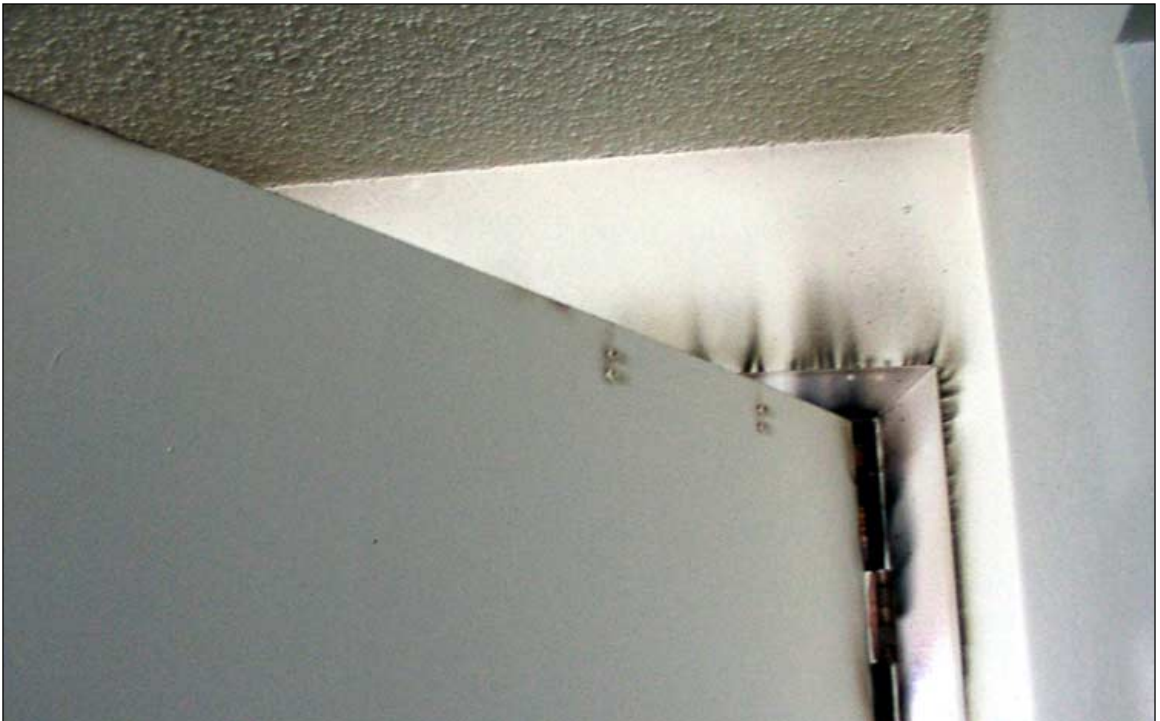
8. Smoke penetration around door into unit on fifth floor.

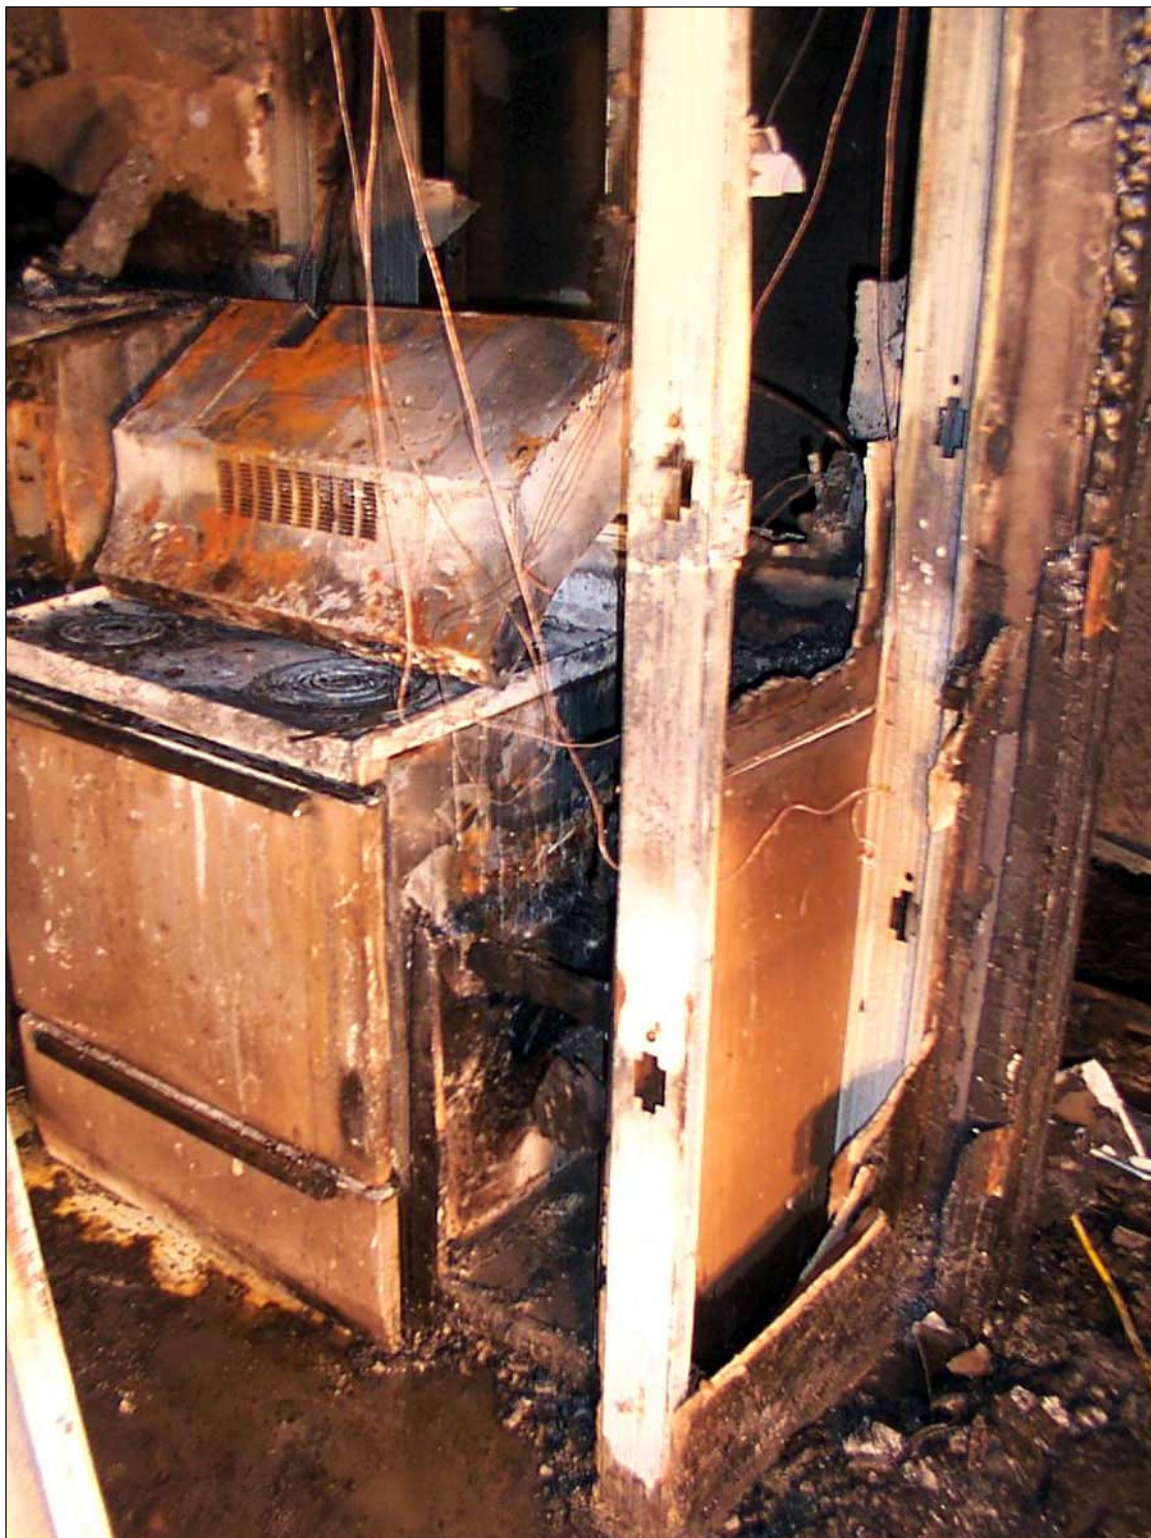
9. Stove and hood in Unit 501, note door opening into hallway right hand portion of picture. Photo shows metal studs, typical of interior construction.

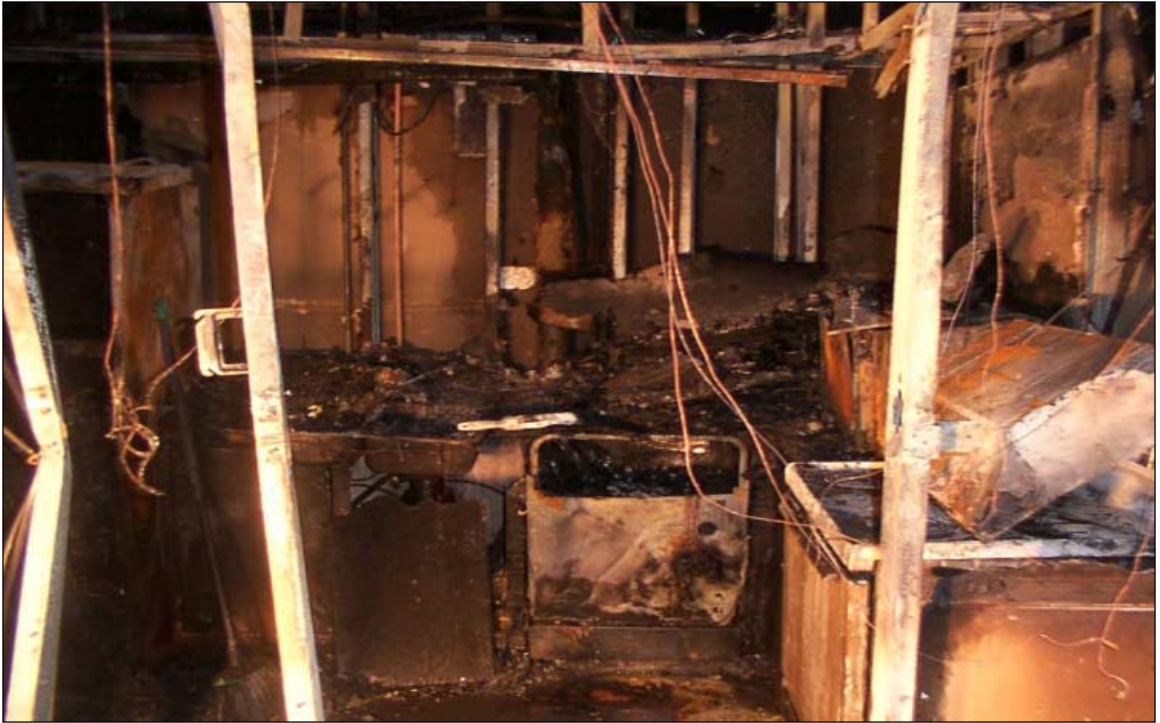
Investigators concluded that the fire was accidental and caused by the burner on the right front of the electric stove located in the kitchen of Unit #501 being left in the on position, which ignited combustibles that were present on the stovetop.

10. Area of origin, kitchen of Unit #501.

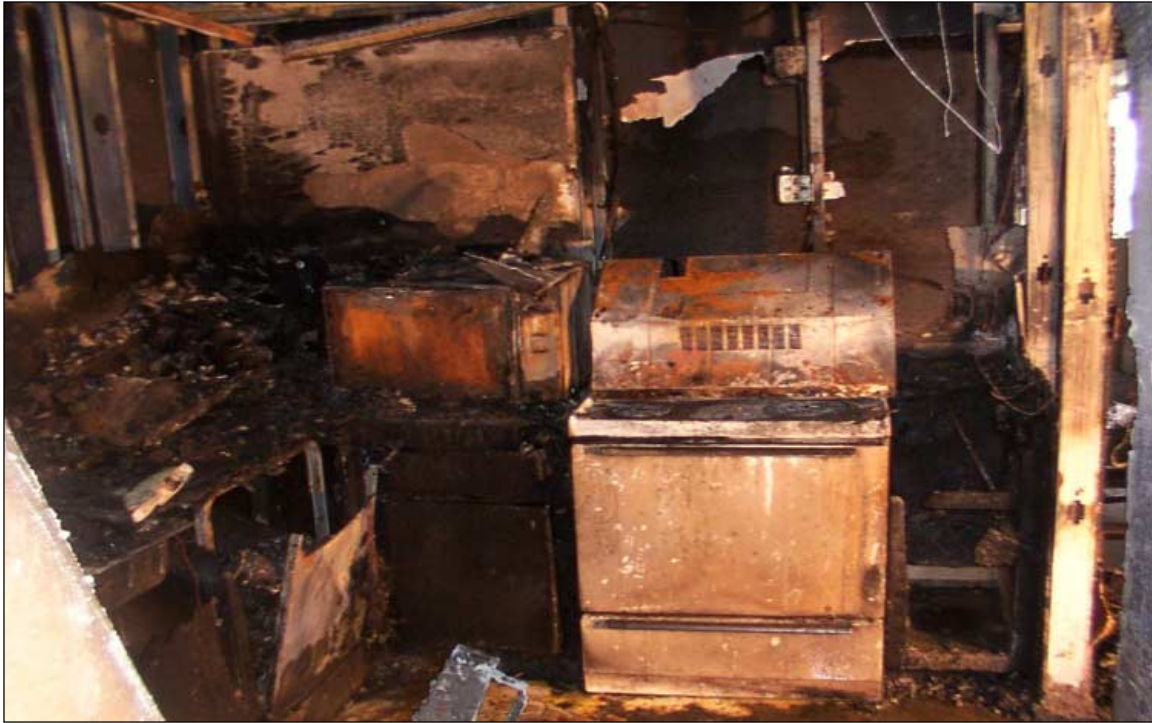
12. Interior view of kitchen showing extent of damage.

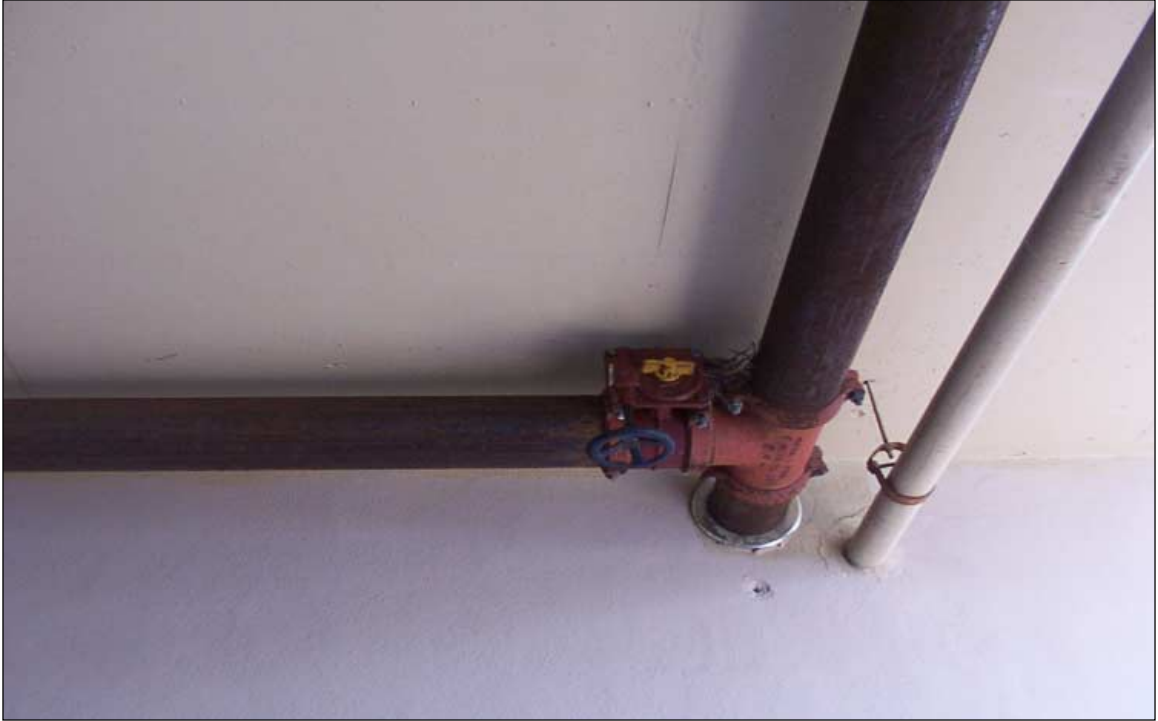
The control valves for the fire pump and standpipe system were monitored for position, except for the valve controlling the water supply to the center riser. For some reason the monitor for this valve was not connected to the fire alarm system. The control valve that was closed was approximately fourteen feet from the ground and not readily visible.

14. Control valve to central standpipe riser found to be closed during fire.

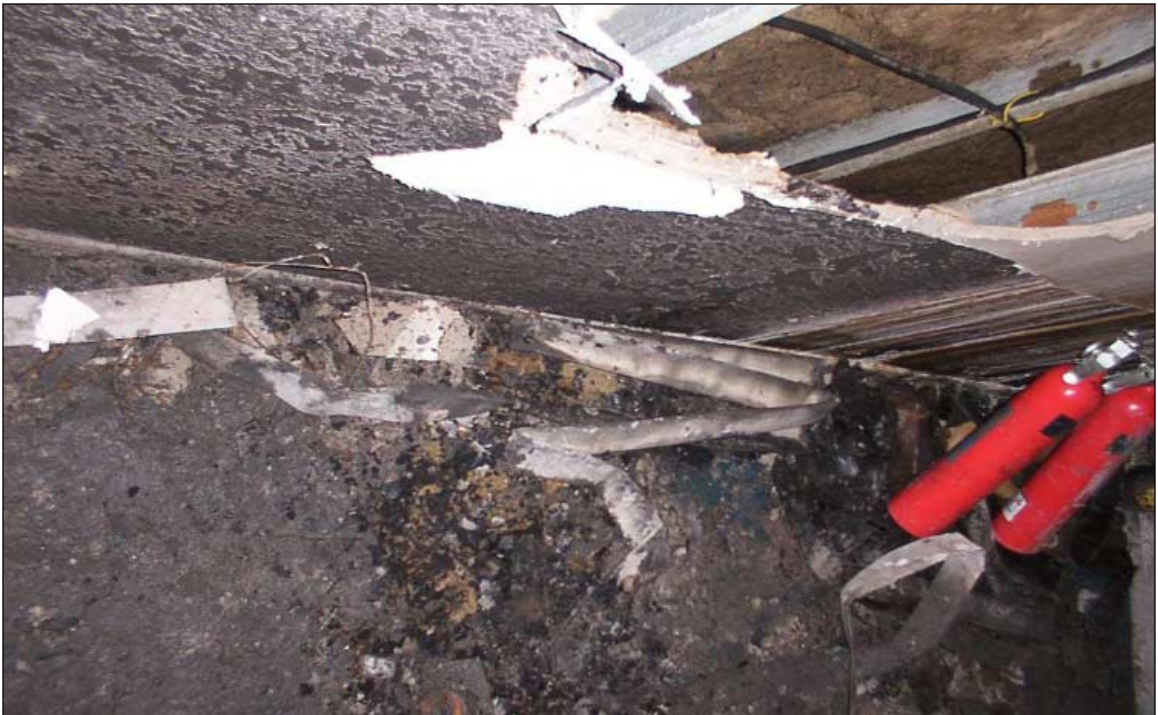
15. Two discharged 5-lb. ABC extinguishers and 11/2-inch house line found outside Unit 501.

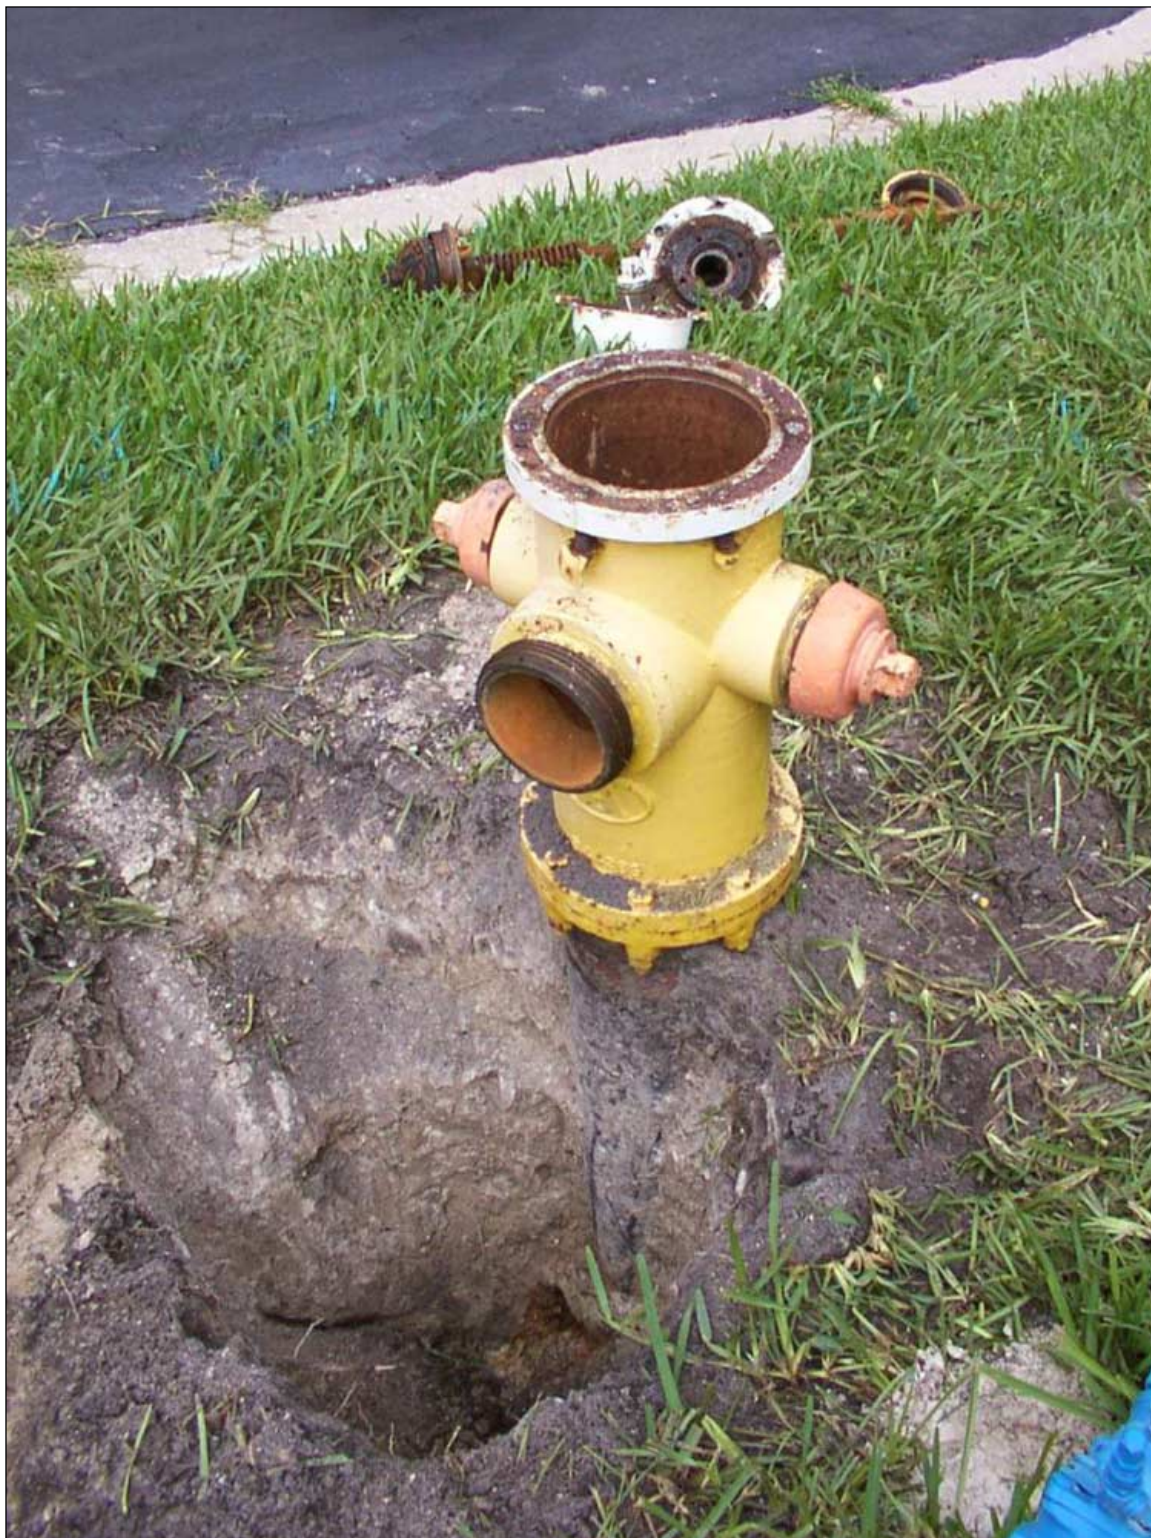
16. Hydrant that failed to operate during fire; note parts in background.

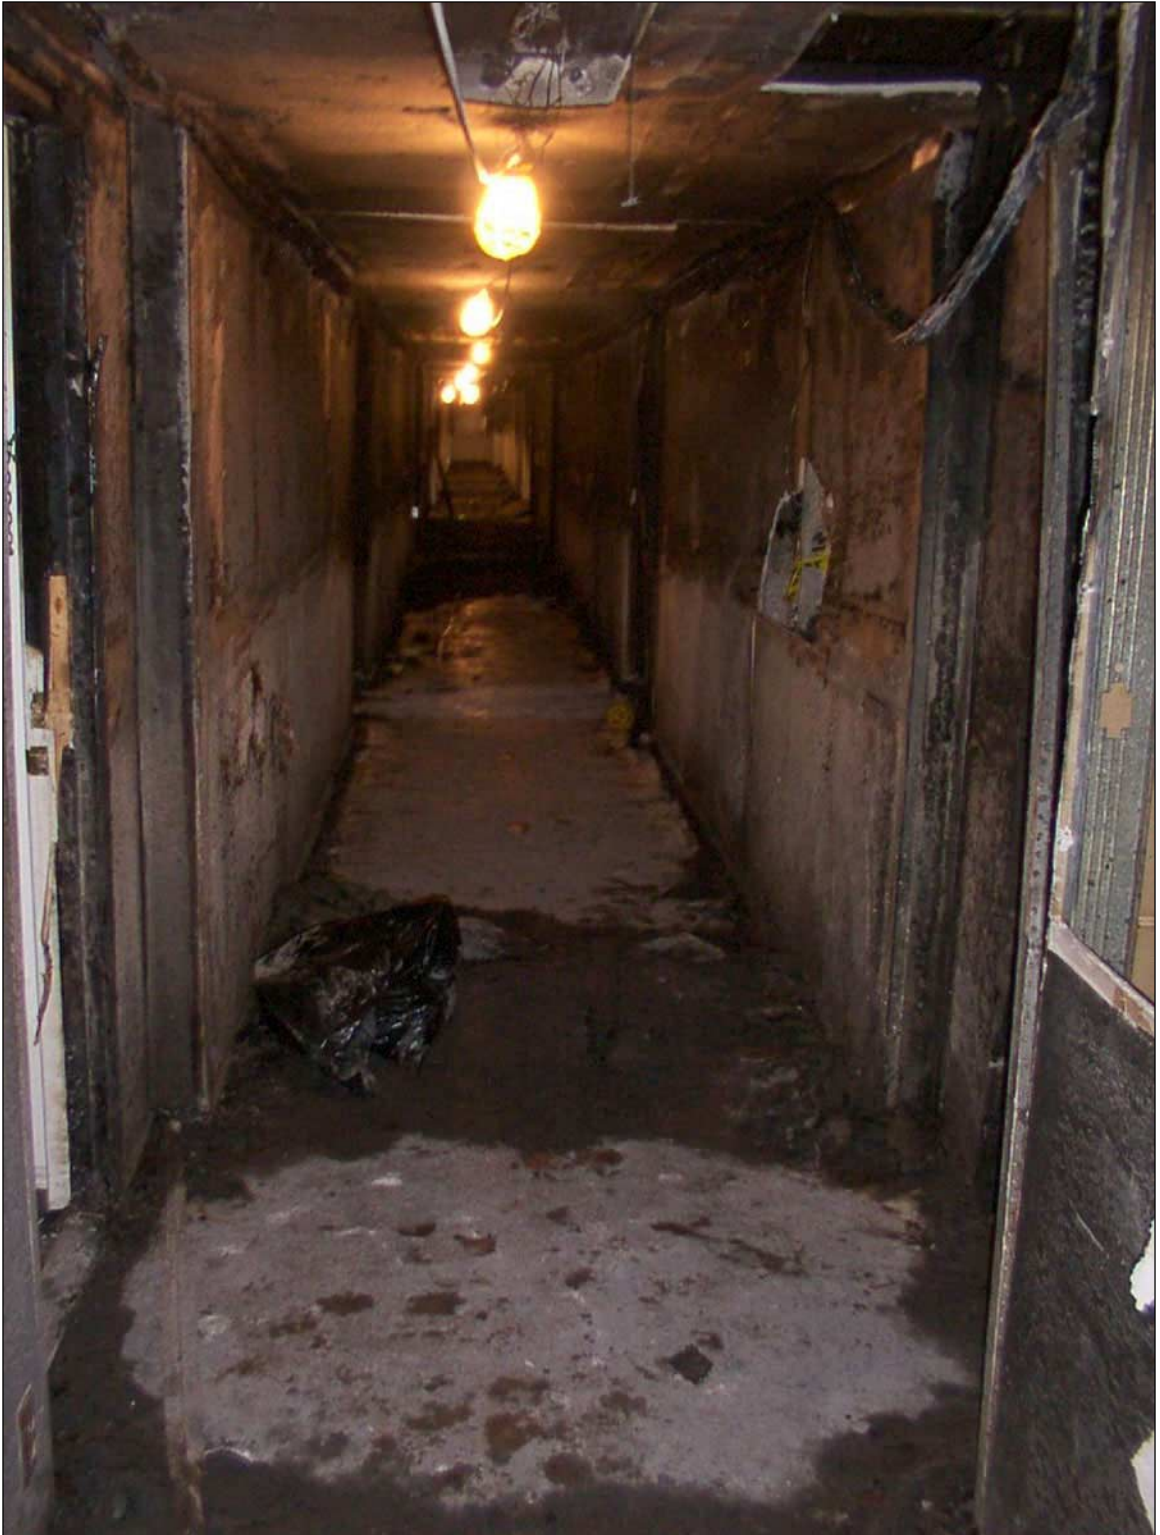
19. Extent of damage to fifth floor hallway.

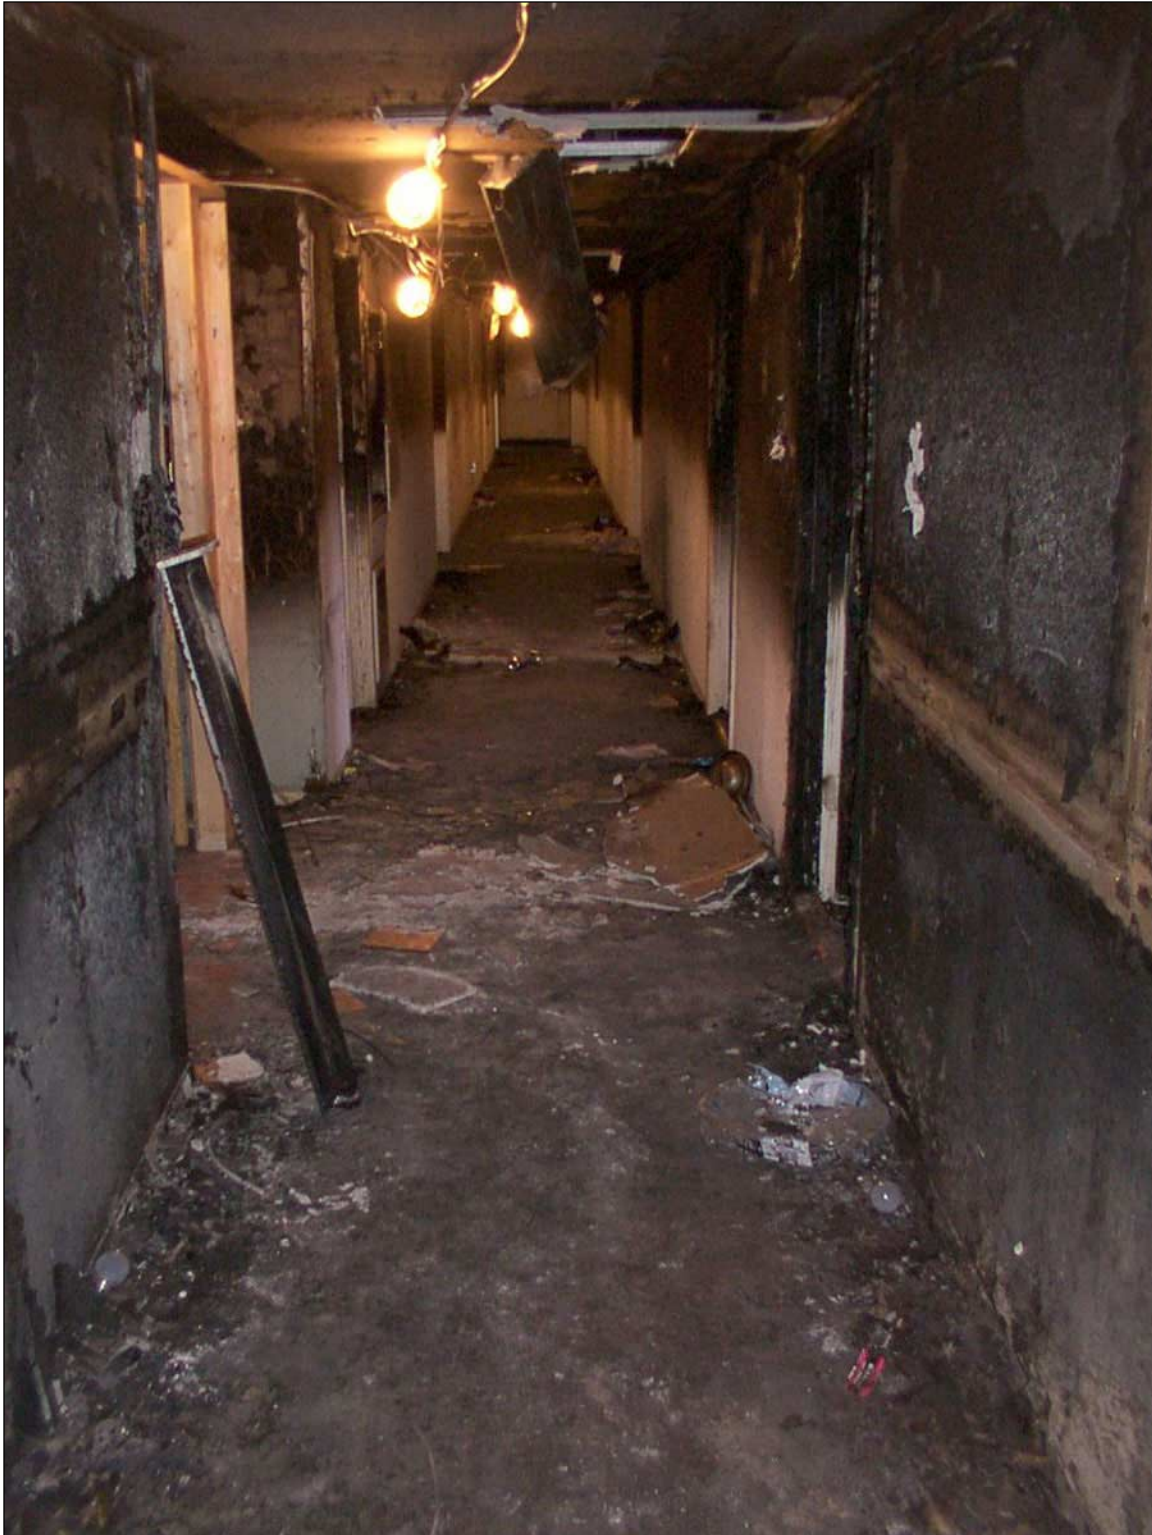
20. Damage to hallway east of elevators, note less damage midpoint to floor.
